## THE PARTHENON 6

## THE ERECHTHEION 7

## THE PROPYLAIA ∞

## THE TEMPLE OF ATHENA NIKE 9

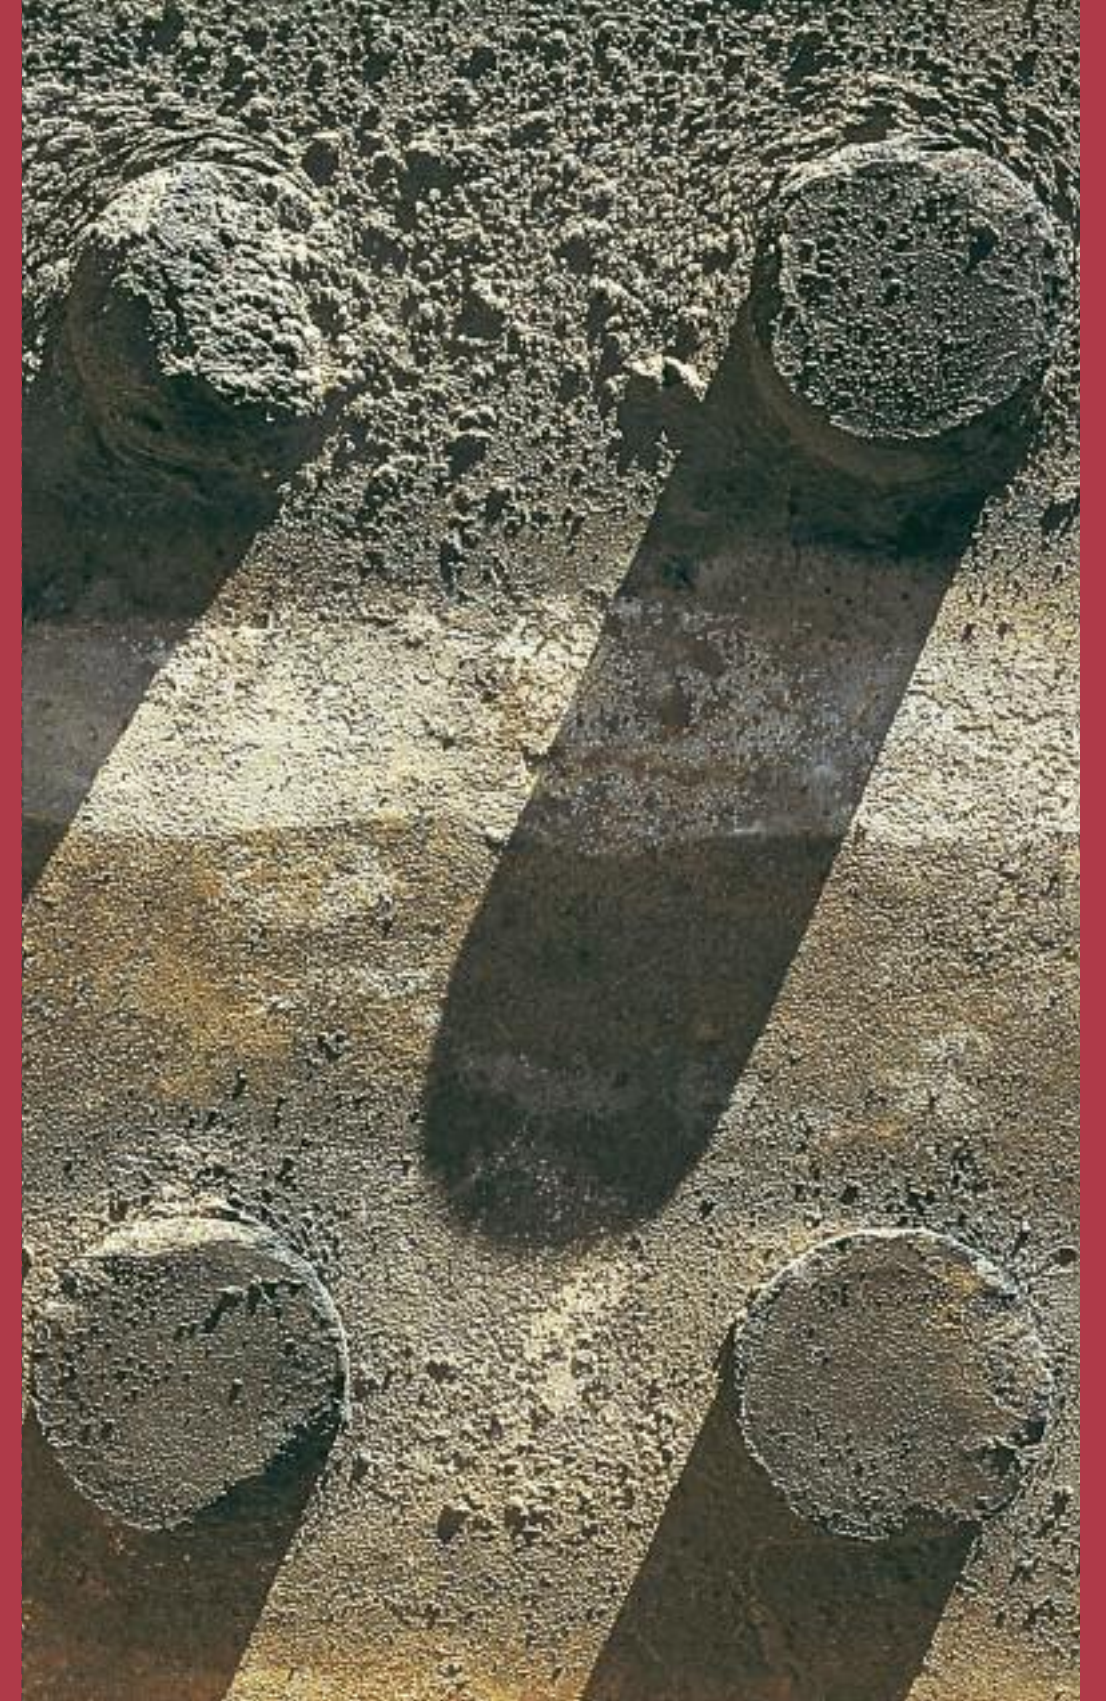
Crusts. Recrystallisation combined with air pollution.

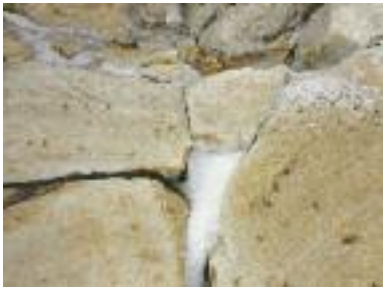
Expansion of cracks due to frost.

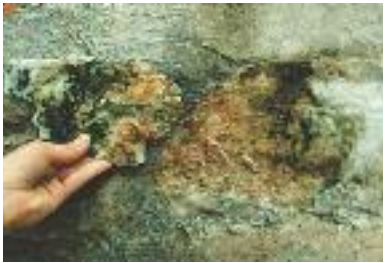
Corrosion of marble due to microorganisms.

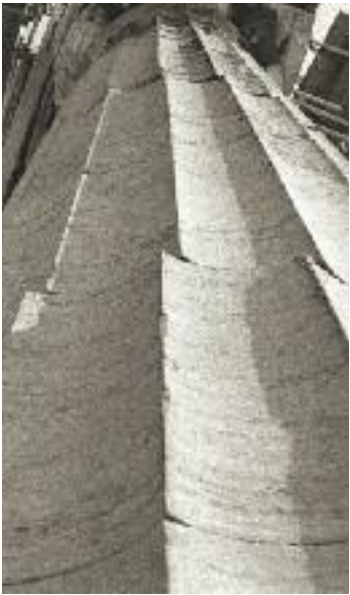
Displacement of the drums of a Parthenon column due to an earthquake.

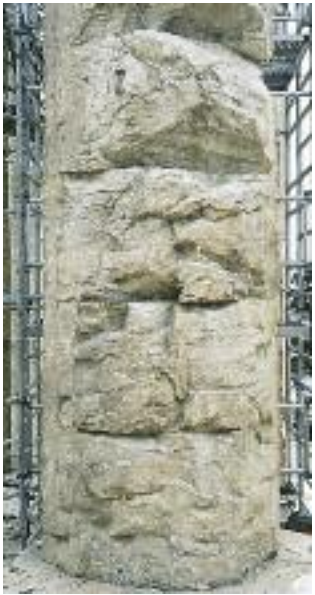
Thermal fracture to a column from the pronaos of the Parthenon.

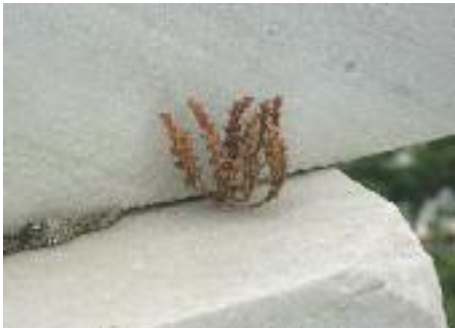
Expansion of cracks due to parasitic vegetation.

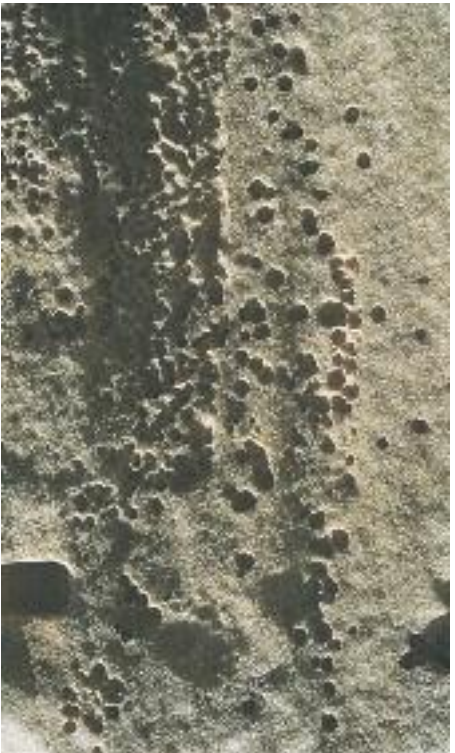
Pitting erosion.

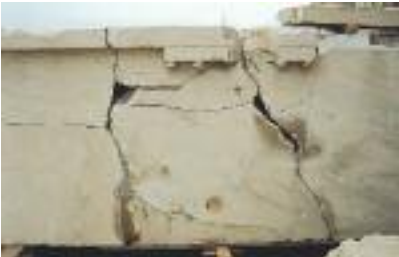
Marble cracks due to the swelling of iron elements. (YSMA Archive)

The results were disastrous: oxidation and subsequent expansion of the iron elements resulting in the fracturing of the marble into which they had been incorporated. During the 1960s, the damage was visible everywhere, with fractures to the marble and pieces falling off. The Balanos restorations were considered very good in terms of

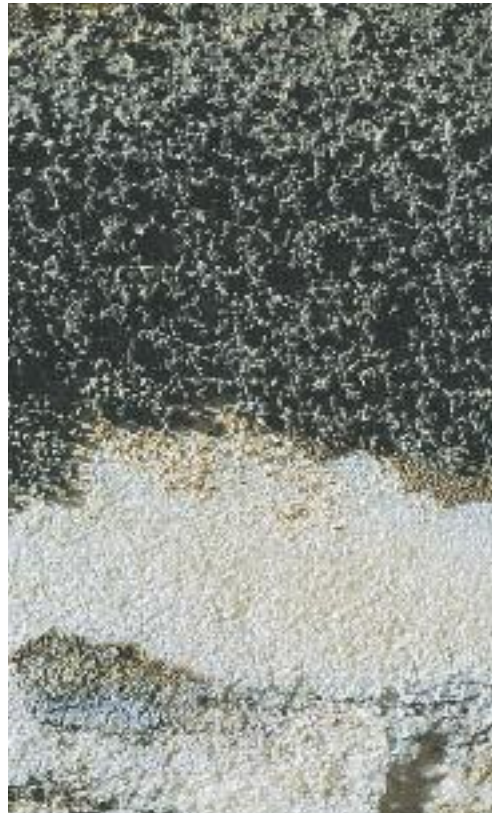
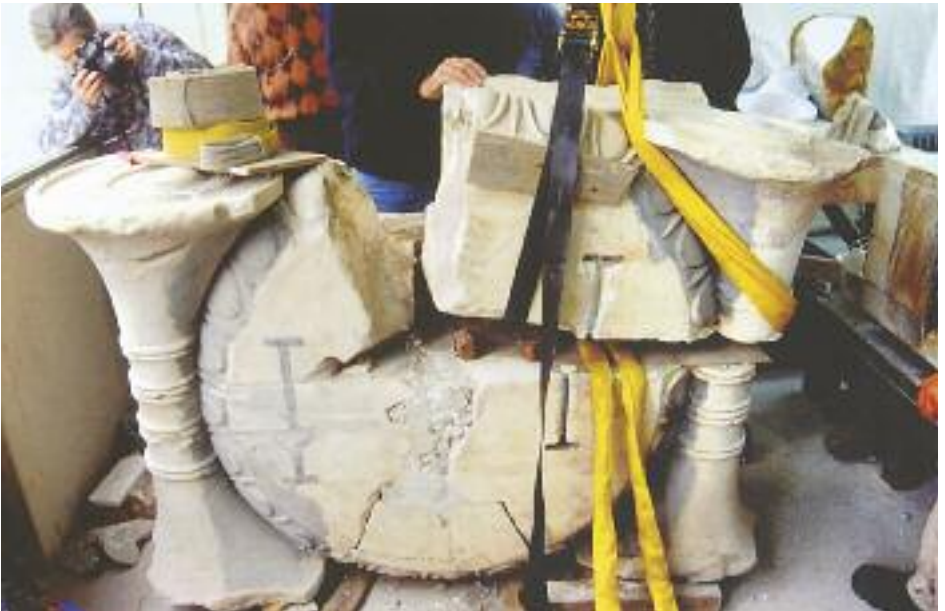
Poor reuse of ancient members. Four sections of different column capitals combined to form one. (T.T.)

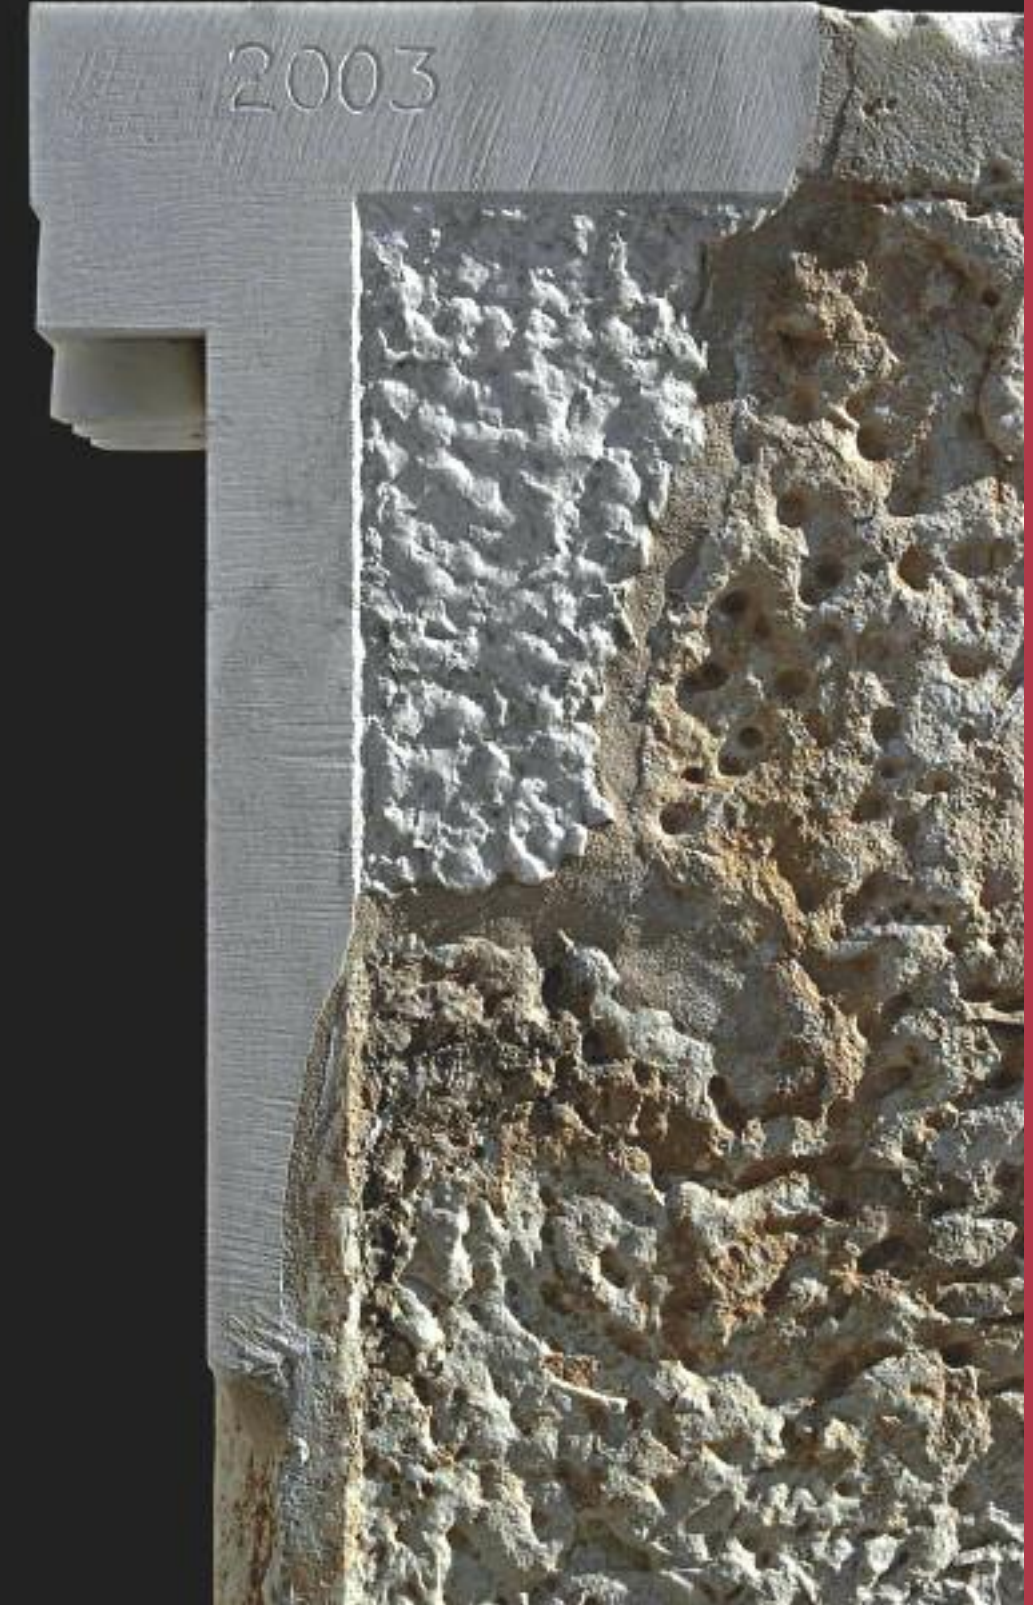
Supplement of new marble in a Parthenon architrave. The year of intervention (2003) can be seen, inscribed on a non-visible surface.

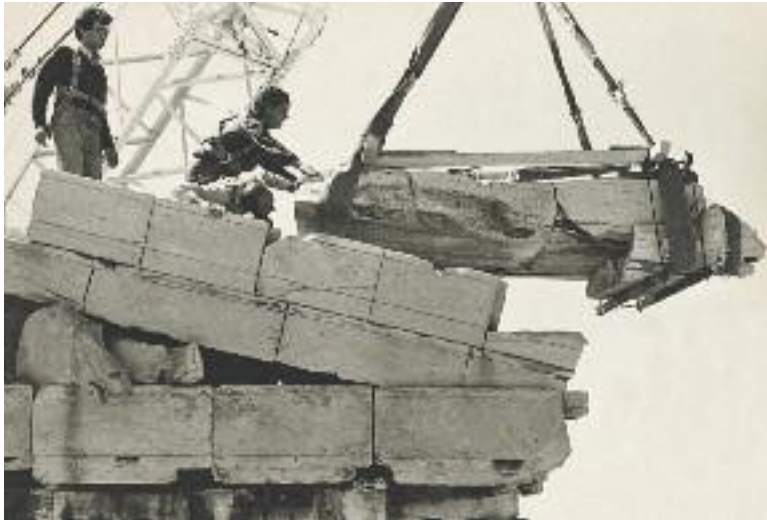
Dismantling the Parthenon's northeast sima with one of the lion-head pseudo-spouts.

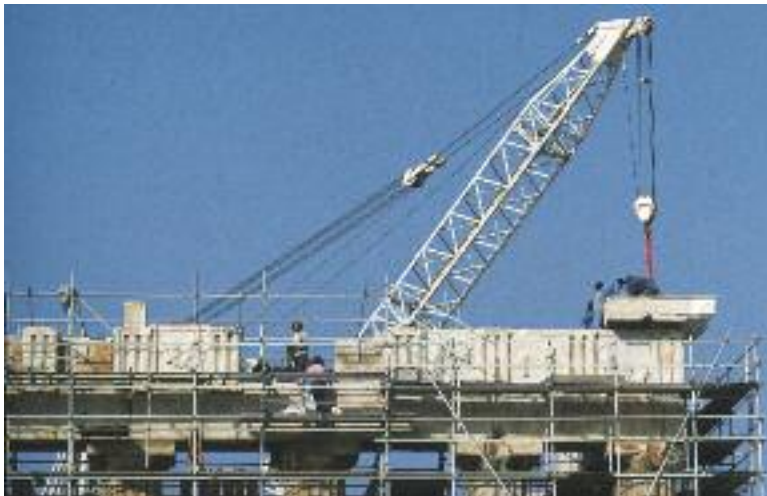
Resetting the cornice of the Parthenon's east side.

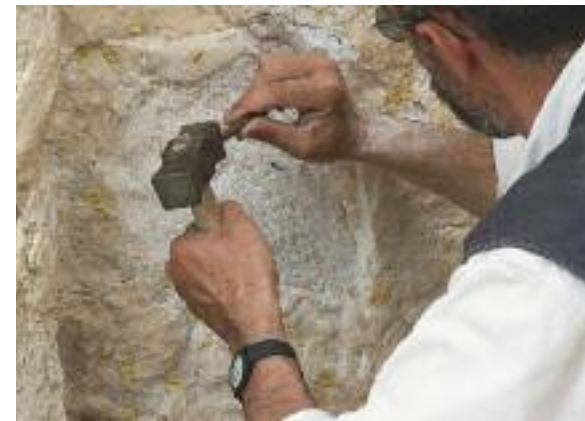
Mechanical cleaning of a marble surface.

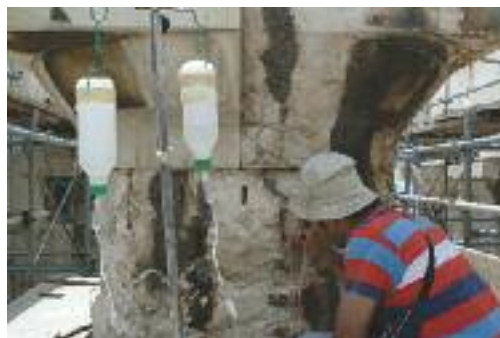
Process of joining internal cracks. Tube system in a column of the Parthenon opisthonaos, for injections of stabilising compound.

The intervention on the **western section** of the building (opisthonaos, 1997-2004), was also of a rescue character. In 1993 over 20 metres of the blocks from the west frieze, the only sculptural ensemble which had remained in its place, were dismantled and transferred to the Museum, since this was proved to be the only solution to the problem of damage by the atmospheric pollution of Athens. This was preceded by the reinforcement of cracked column drums with injections of stabilising compound.

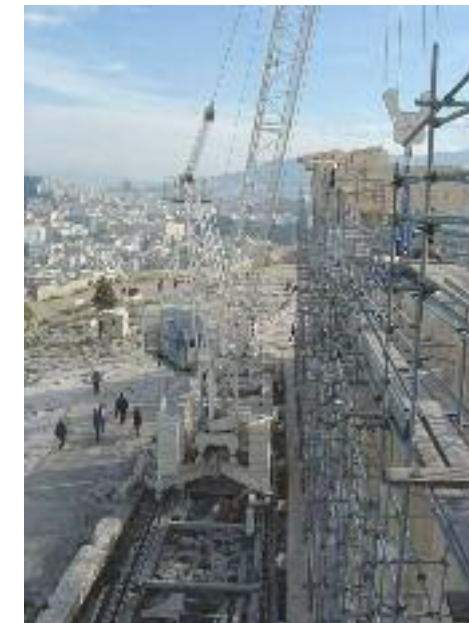
The rotating construction crane on the north side of the Parthenon.

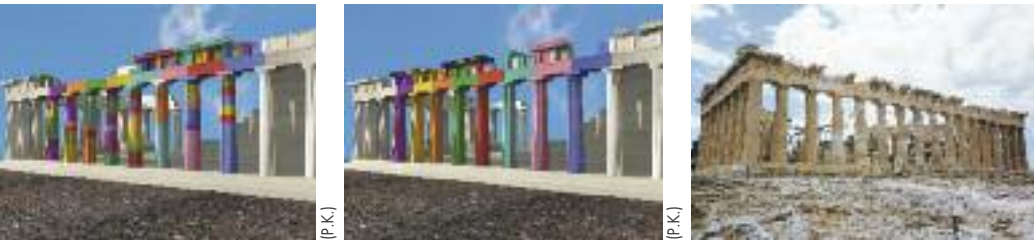
Digital imaging of the north colonnade, with different colours indicating the misplaced drums before the restoration, and after repositioning in their original places.

In the north colonnade, eight columns and their entablature, which had been misplaced, a total of 230 architectural members weighing 900 tons, were dismantled in order to be repaired and to be returned to their initial positions in the monument. All of the cement drums from the 1923-33 restoration were replaced with new ones of Pentelic marble. Most of the metopes were transferred to the Museum, while copies in artificial stone were set on the monument.

The rescue interventions also include work on the **north colonnade**. Eight columns along with their entablature, a total of 230 architectural members weighing 900 tons, were dismantled in order to remove the rusted iron elements and to return them to their initial positions by correcting the misplacements of the first restoration. The program also included the replacement of cement drums from the 1923-33 restoration, with new ones of Pentelic marble. Most of the metopes were transferred to the Museum and were replaced with copies in artificial stone. The work was completed in 2010. The sections of the **side walls** of the cella, that had been restored prior to 1930, were dismantled so that the rusted iron connectors could be removed from the blocks, and the walls were completed with blocks that were identified from scattered architectural members lying around on the Acropolis. The study for the new restoration of the walls, including the resetting of the 350 members identified, is in its last stage, as is that of the intervention on the lintel of the entrance to the opisthonaos, that is, the removal of the reinforced concrete lintel remaining from the Balanos restoration and its replacement with marble.

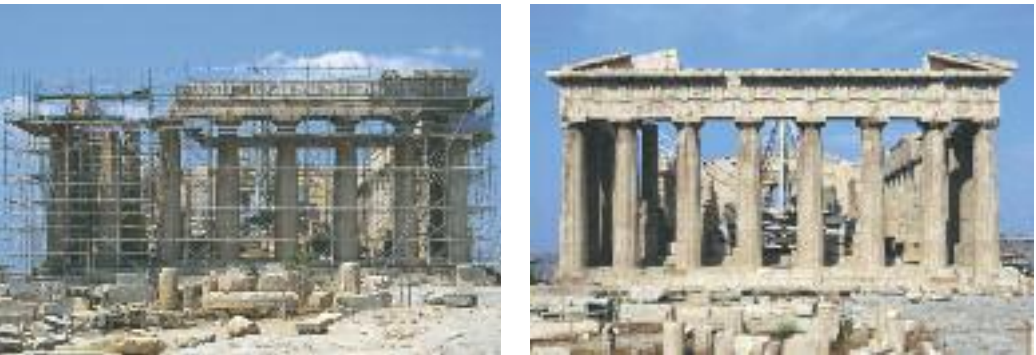
The east façade of the Parthenon during and after completion of restoration. On the east side 160 architectural members were dismantled. They underwent repairs and conservation work and were returned to their positions. All of the metopes were removed and transferred to the Museum, while on the monument they were replaced with copies of artificial stone.

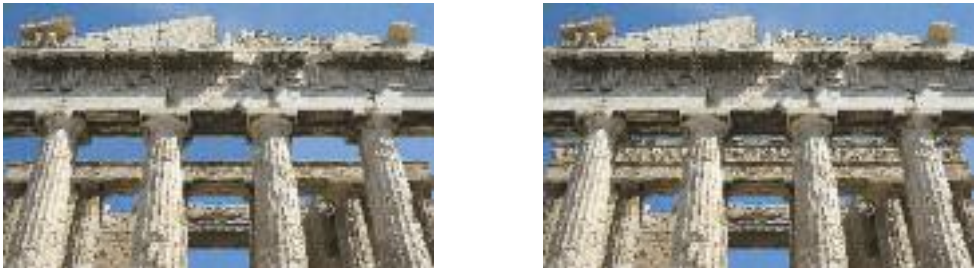
The west façade of the Parthenon during the intervention and after completion of the restoration. Approximately 130 architectural members from the opisthonaos were dismantled, repaired and returned to their positions. All the frieze blocks were removed and transferred to the Museum, while copies in artificial stone were put in their place on the monument.

A rescue intervention is underway on the **west façade** of the temple. This involves the dismantling of the two ends of the pediment and entablature where Balanos had intervened, the removal of rusted metal elements, structural restoration of many cracked members, and the transfer of six metopes to the Museum as well as their replacement with copies in artificial stone. The extensive restoration of the east interior porch of the temple (the pronaos, 1995-2004), which had only one column in its place, comes under the [enhancement works](#) on the Parthenon. Two more columns were entirely restored and another three in part, using both the whole and fragmented colonnade material, that was collected from members lying on the ground. The carving of the flutes on the column supplements still remains to be done. In the domain of [conservation](#) all the architectural members which were moved, were checked and underwent minor interventions: joining of chips and small fragments, sealing of cracks, removal of organic and other deposits, and removal of recrystallised layers.

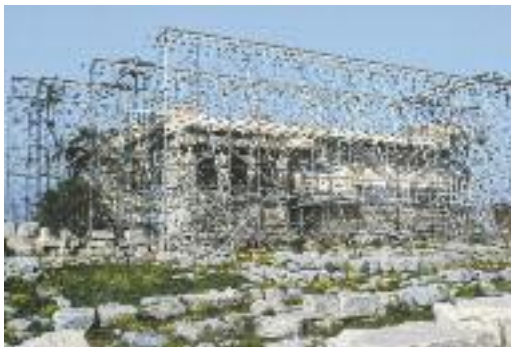
The southwest façade of the Erechtheion during the interventions and after completion of the work.

*Interventions were made on all four sides of the temple, in order to correct the errors of the earlier restoration interventions. A total of 720 architectural members were dismantled, which underwent repair, conservation and filling, where appropriate.*

Included in the [rescue interventions](#) were the dismantling of the porch of the Caryatids, the south wall, a section of the west wall, the ceiling of the north porch and the north wall – a total of 720 architectural members. The aim was the removal of the rusted iron beams and connectors (clamps and dowels) from the Balanos restoration, the joining together of fragments and, occasionally, the filling of architectural members with new marble in order to achieve their structural restoration.

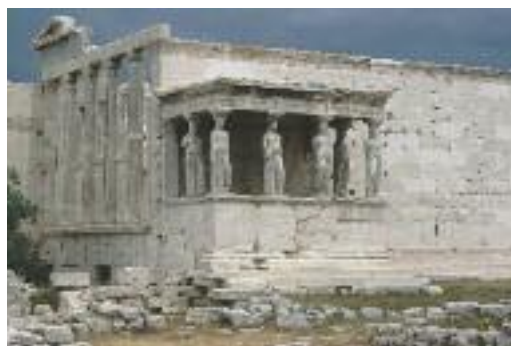
View of the south side of the Erechtheion after restoration.

*In the north and south walls of the temple misplaced members were returned to the positions they had occupied in antiquity, and the voids that were created in the monument's structure were filled with members made entirely from new marble. The ceilings of the north porch and of the porch of the Caryatids were dismantled and the rusted beams from the earlier intervention were removed, after which they underwent conservation work and were reassembled.*

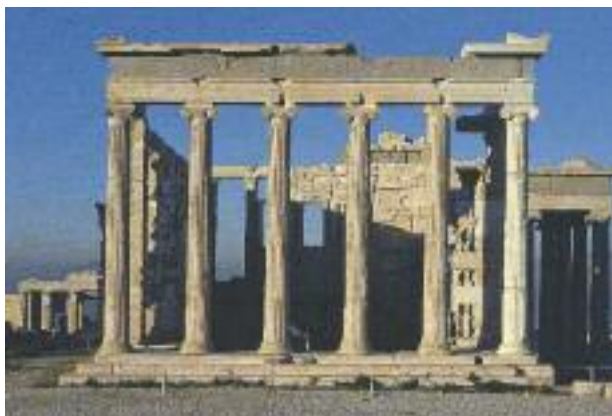
*The northeast corner of the temple regained the closed form of the hexastyle porch which it had in antiquity, as copies in artificial stone were set in the place of the Ionic column and overlying entablature, the originals of which are in the British Museum.*

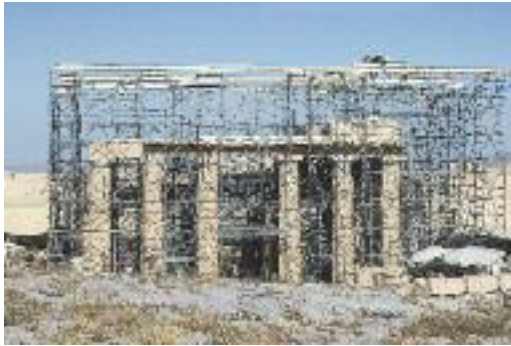
The Propylaia from the east side during and after its restoration.

*On the east hexastyle porch, the intervention has reached the third column drum. Approximately 200 architectural members were dismantled, underwent repair, conservation and filling where appropriate and were reset in place.*

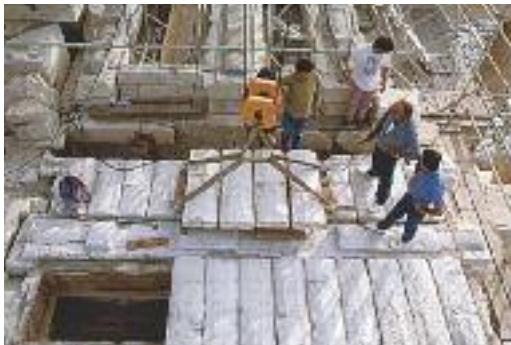
Dismantling of coffered slabs from the roof of the Propylaia's central building. (T.T.)

*The coffered ceilings that had been previously restored were dismantled, studied alongside the coffer and beam fragments on the ground, joined together, and reset in their original positions.*

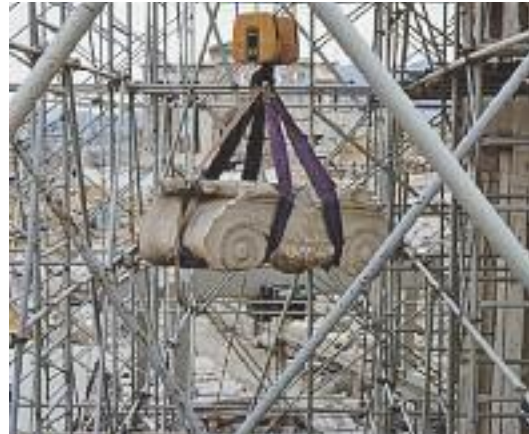
Dismantling of an Ionic capital from the central hall.

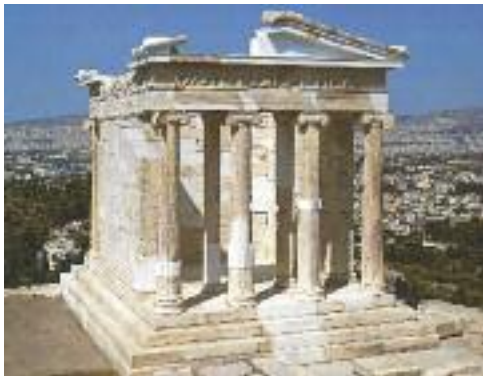
The temple of Athena Nike during and after its reassembly.

*The temple was dismantled in its entirety – a total of 319 architectural members – and underwent repairs, conservation and filling, where appropriate. Misplacements from previous restorations were corrected.*

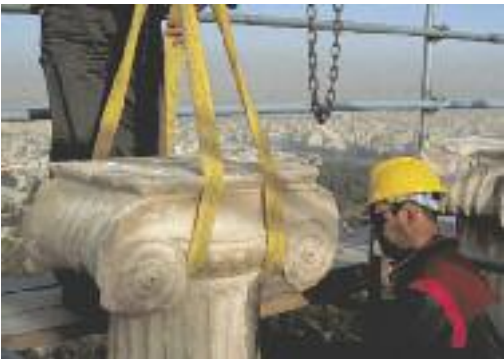
Dismantling the capital and moving the shaft of a monolithic column from the temple of Athena Nike.

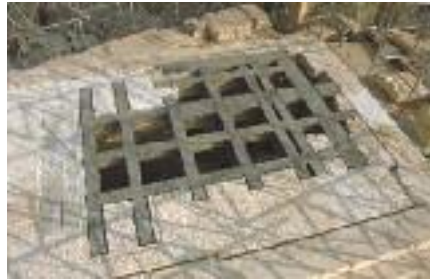
The new metallic grid of the temple of Athena Nike.

*Conservation work was carried out on the remains of the small archaic poros temple located 1.80 metres below the floor of the Ionic temple and accessibility to the underground site has been improved. A new metallic grid of stainless steel was created to replace the reinforced concrete slab. Following the restoration, the temple's marble floor is now supported on this grid.*
